PRODUCT TECHNICAL BULLETIN 36339 MWM INLET MANIFOLD WELD FAILURE

Date: 08-05-2024
Issue: A (release)
Prepared for: Industry/ End Users

Applicable machines: MWM 4.1TCA engines used in underground coal mines design registration MDR 114056 DES.

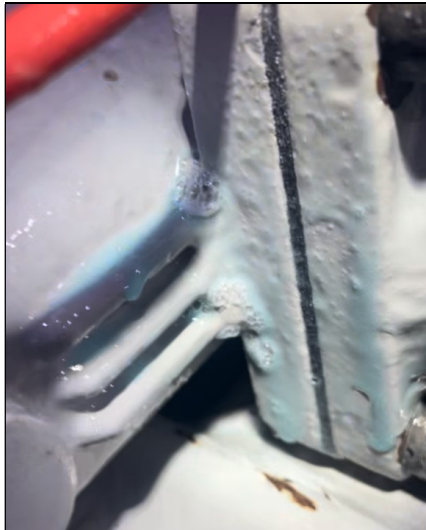
During soapy water testing, a leak was detected on the flange weld of the MWM inlet manifold 7-054441-700. The leak was found to have been due to weld cracking through the throat area of the internal weld connection and propagating to the external stitch weld.

Figure 1: External leak through stitch weld

- The specific Manifold could not be identified via its serial number with OEM records.
- The weld method had been revised from an external stitch weld to a full weld since 2015 and hence the age of manifold was estimated to be approximately 10 years.
- Weld size was lacking on the external stitch weld and had led to an overloading of the internal weld.

- Inlet manifolds should be subject to non-destructive testing of the flange welds during a code D overhaul.
- Inlet manifolds that are not fully welded on the external weld are recommended to be replaced at the next available service opportunity.

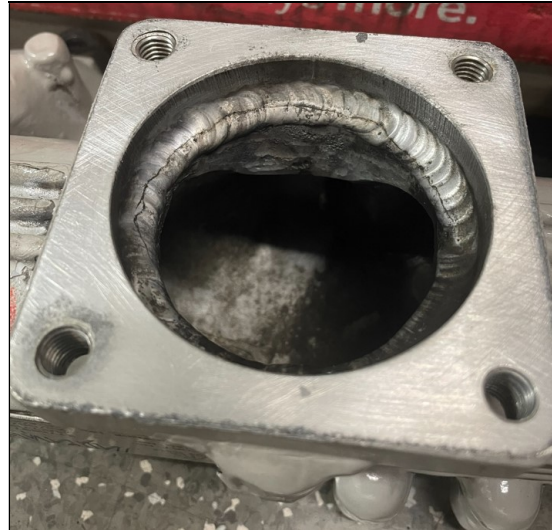
Figure 2: Crack through internal fillet weld

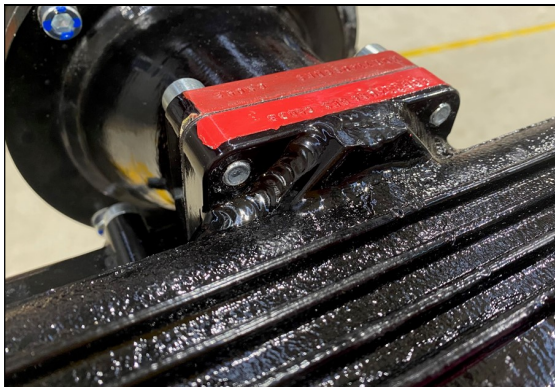
Figure 3

Figures 3 & 4: Inlet Manifold views examples of fully welded flange connection
